## **Fort Leonard Wood Cantonment Landscape Context, Inventory, and Management**

Megan Weaver Tooker, Sunny Stone, and Adam Smith

September 2007

Final report

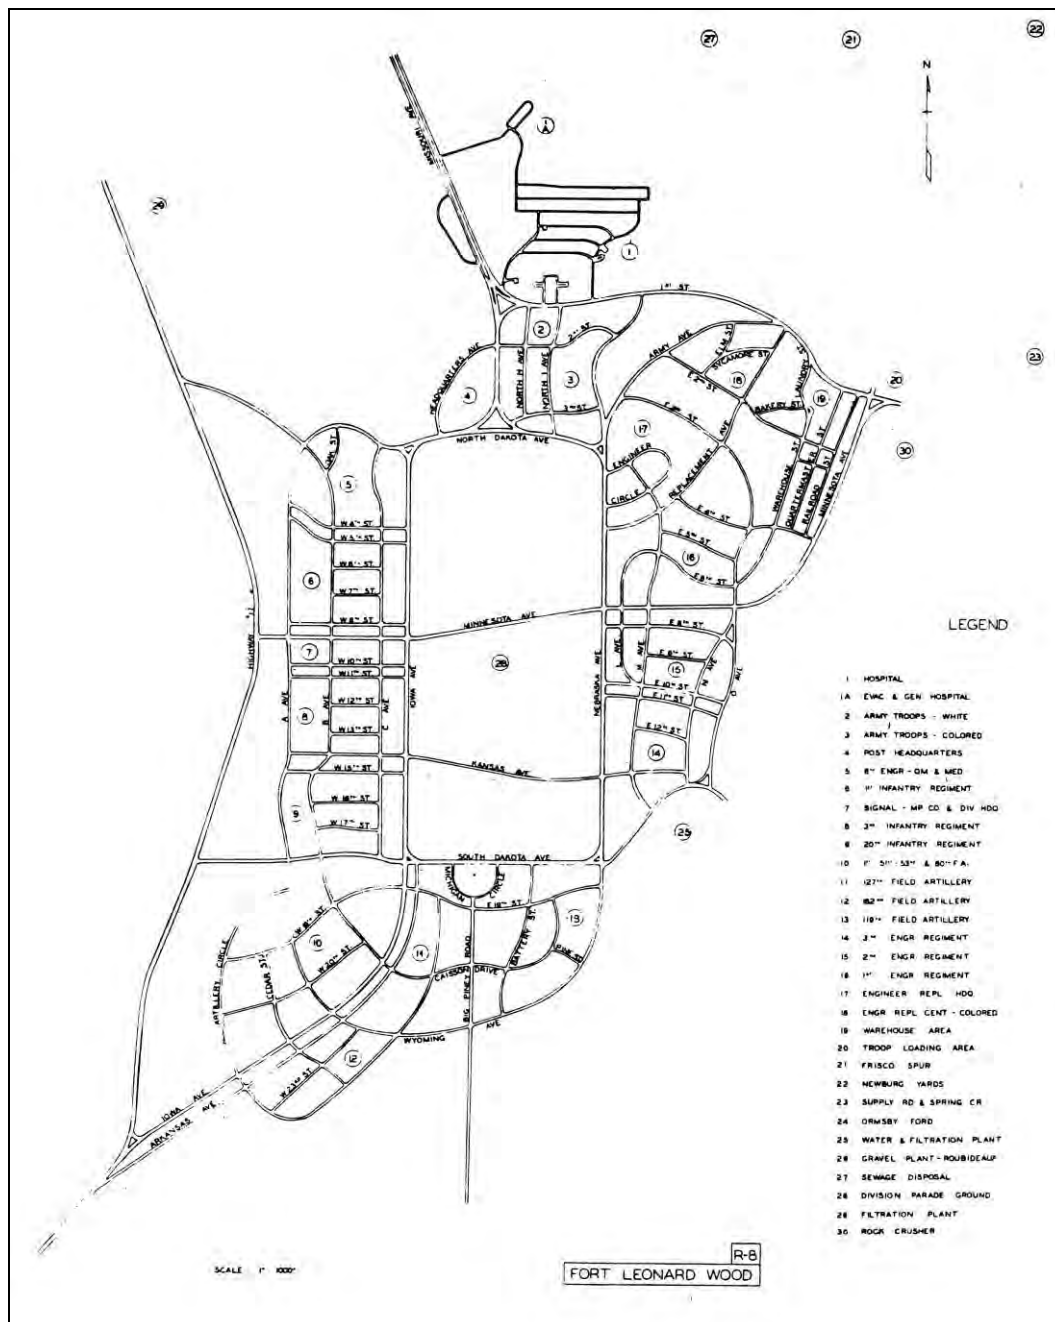
Figure 13. Map of roadways, 1941 (Robinson, *Landscape Development Plan*, 1941).

The 1941 report noted that the road layout achieved “a natural and attractive appearance” at a minimum of cost.<sup>22</sup> For the most part, the intricate curvilinear WWII-era roadway system remains today (Figure 13). Large construction projects, such as rows of rolling pin barracks, modern barracks, and Building 1000 at the southern end of the parade ground, built during the Cold War era and present day have eliminated some of the tertiary roadways. In addition, the WWII firebreaks and associated circulation networks have been built over. Smith noted in his *Historic Context Statement for a World War II Era Black Officers' Club*, that a comparison of the WWII period and modern maps indicates only a few road changes from the original WWII layout and as a result, “the center of Fort Leonard Wood retains much of its WWII landscape” (Figure 14).<sup>23</sup>

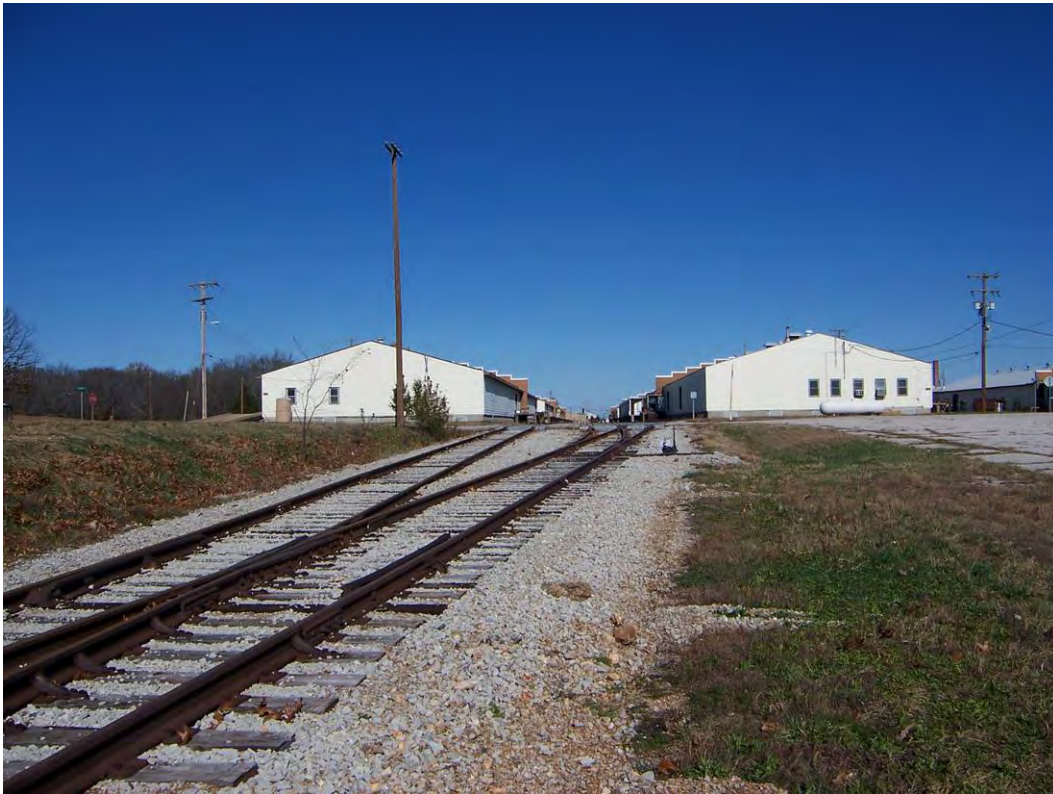
Figure 16. Railroad track and warehouse area in northeastern corner of the cantonment (ERDC-CERL, 2005).

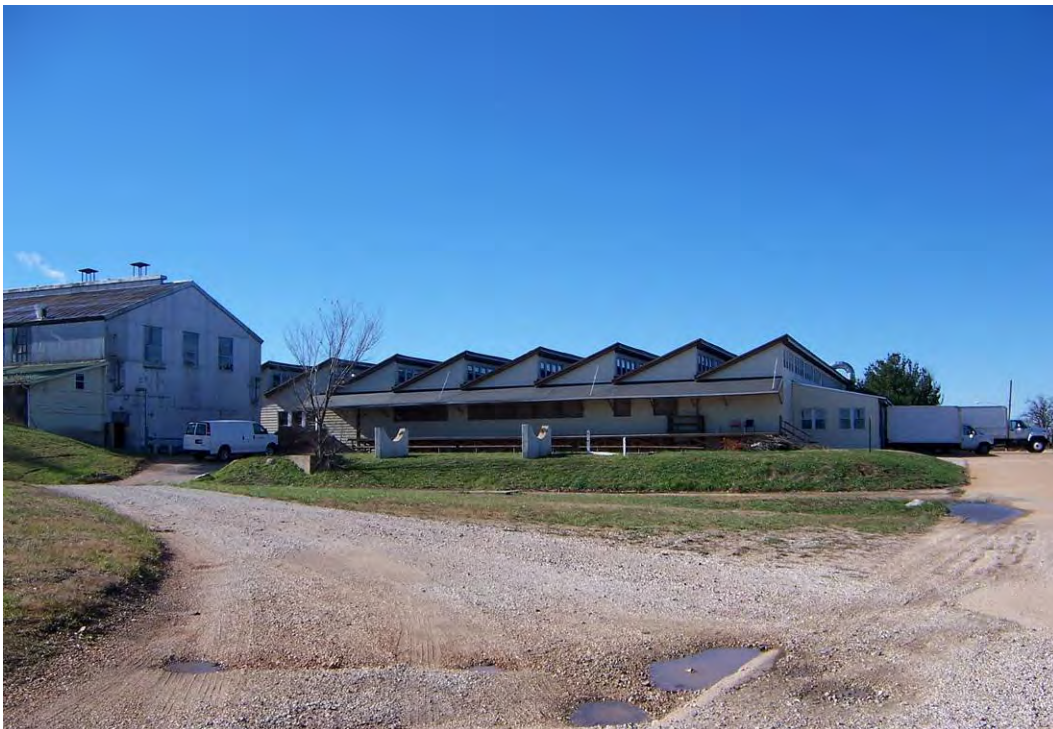
Figure 17. WWII-era laundry and steam buildings in warehouse area (ERDC-CERL, 2005).

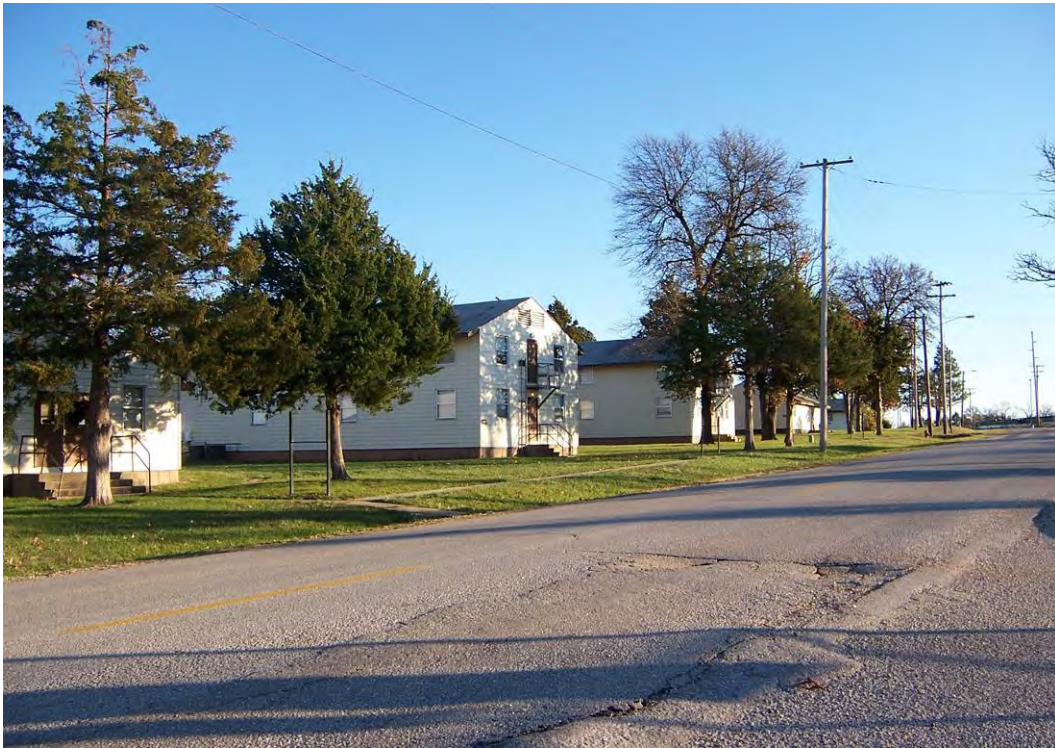
Figure 18. WWII temporary buildings used by the Missouri National Guard located in the southwestern corner of cantonment (ERDC-CERL, 2005).

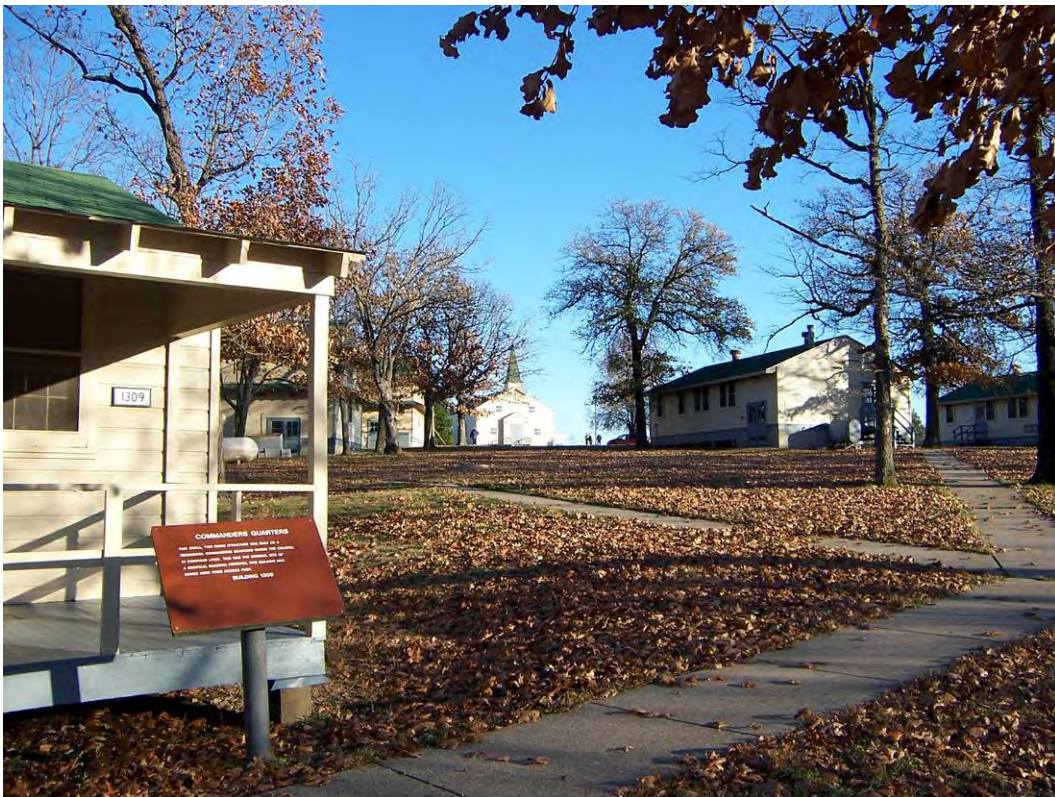
Figure 19. WWII temporary buildings in historic district and museum (ERDC-CERL, 2005).

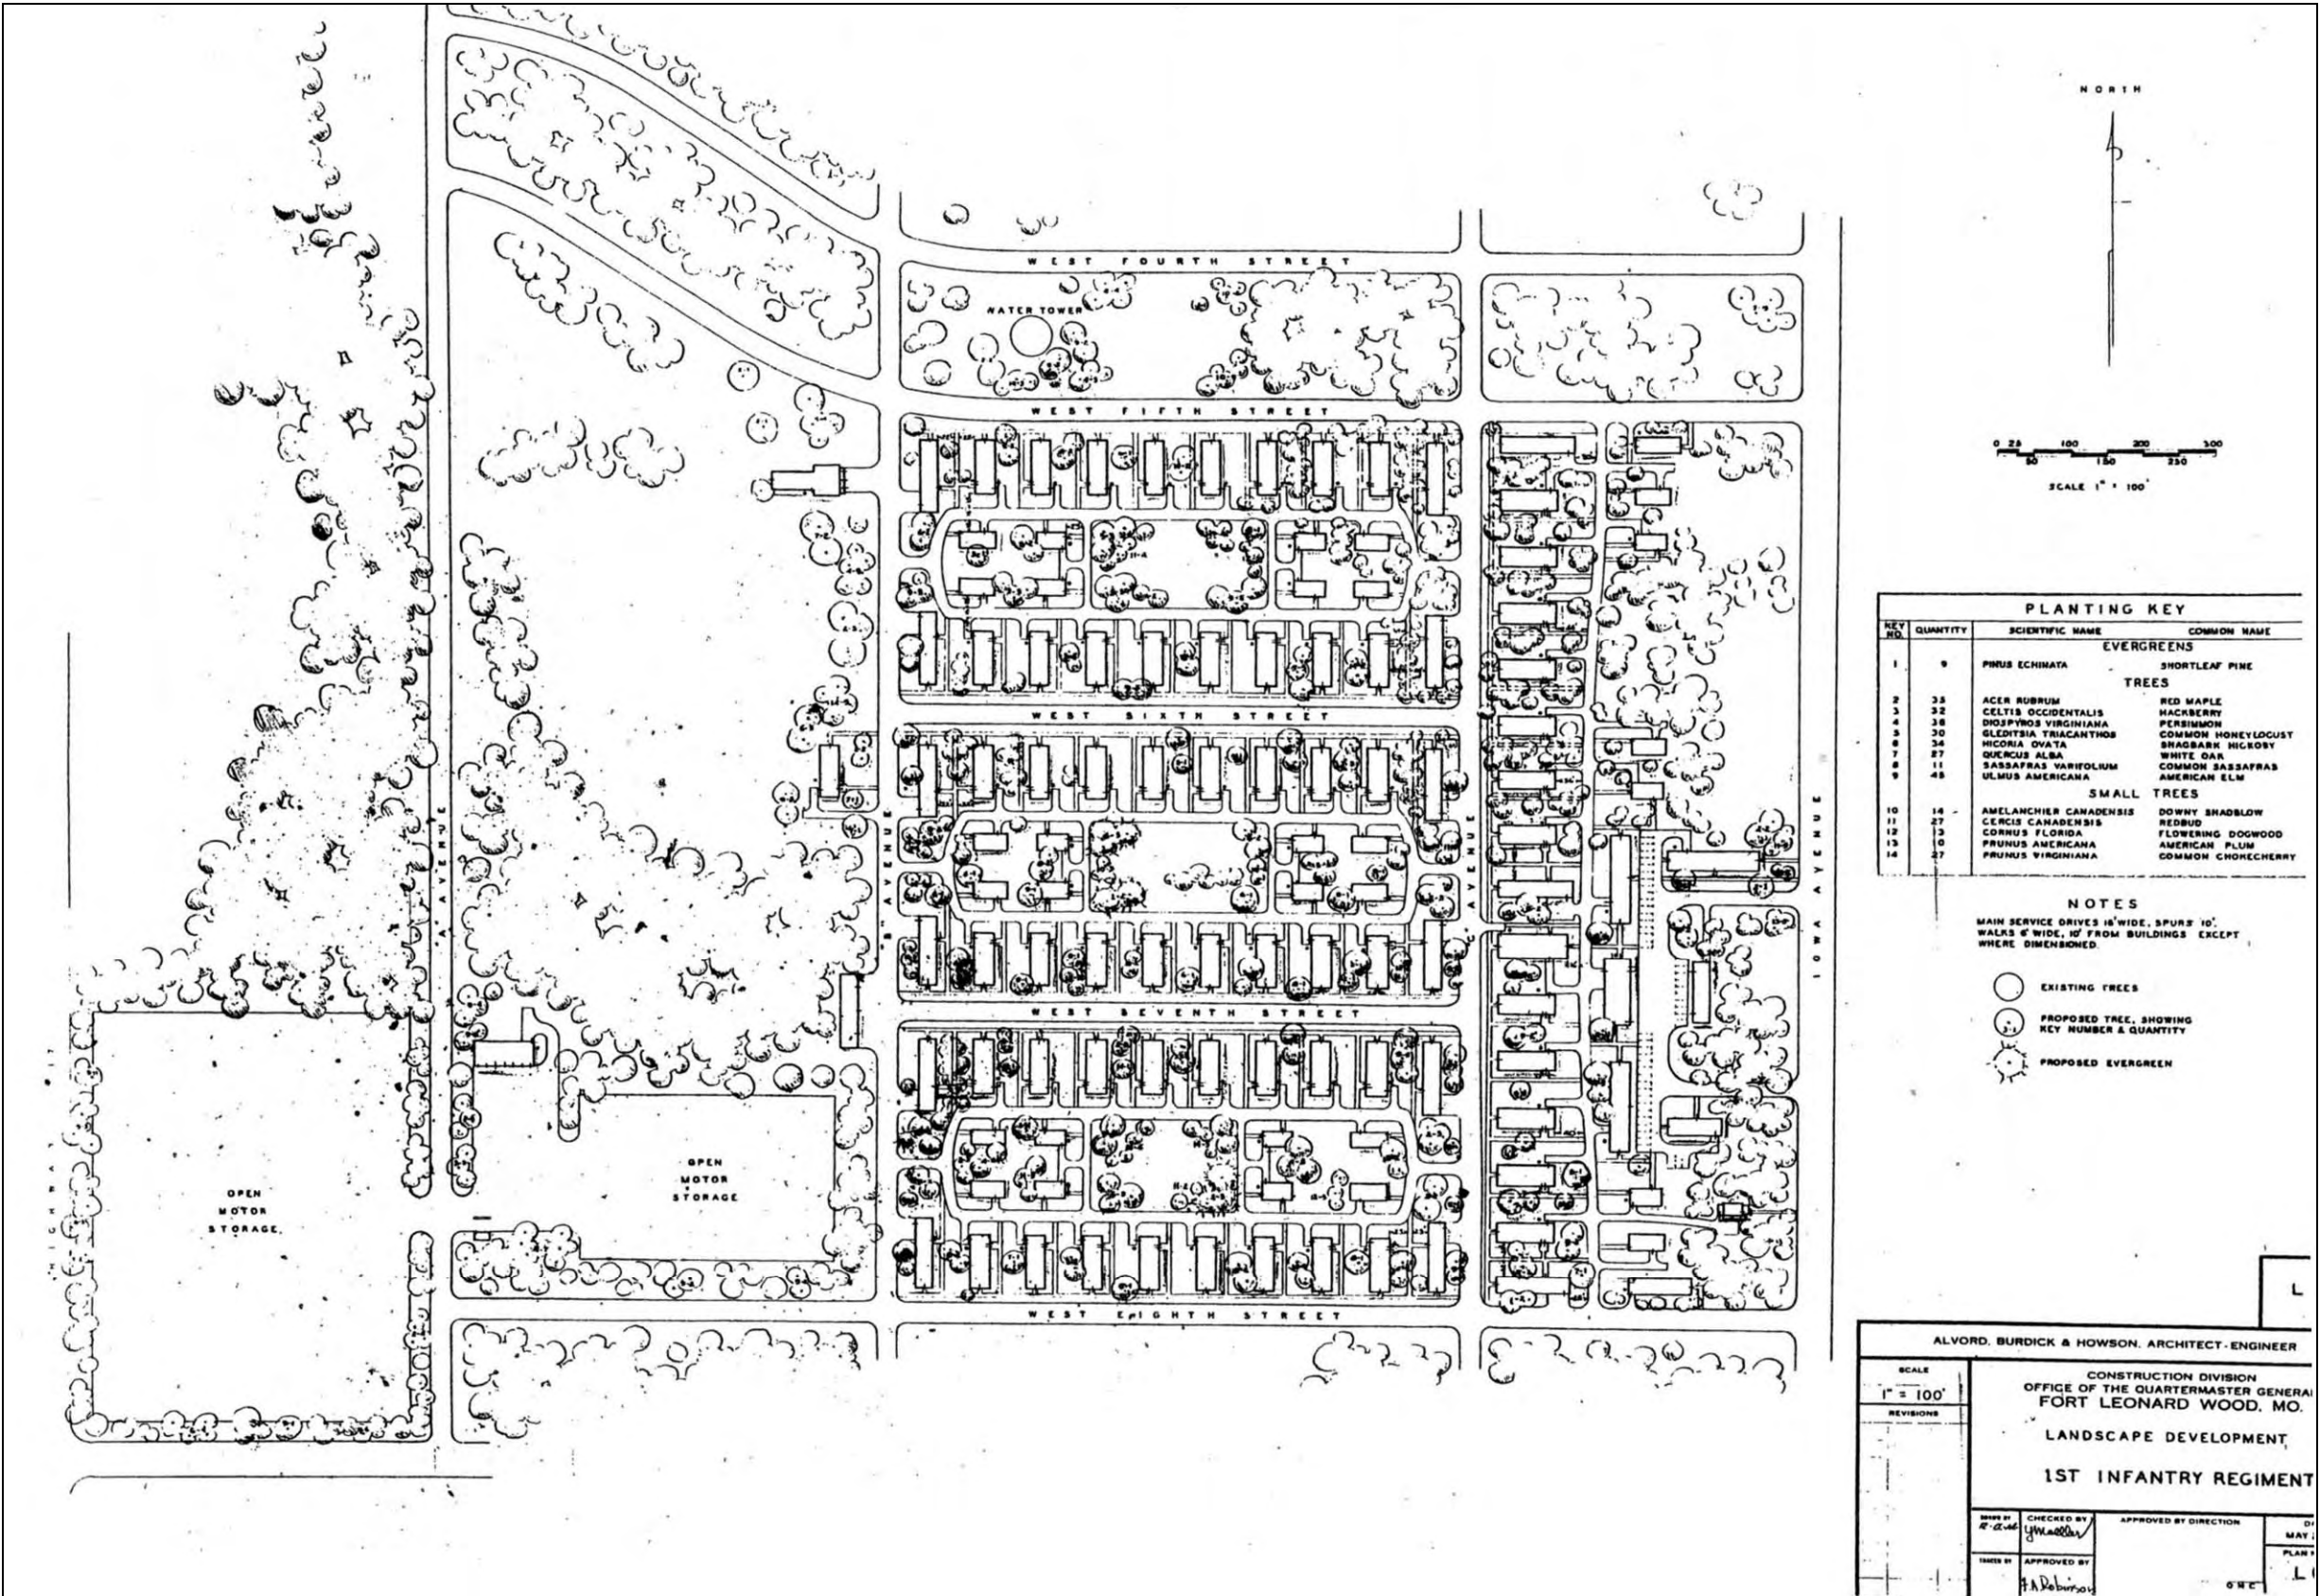
Figure 25. Landscape Development, 1<sup>st</sup> Infantry Regiment, Alvord, Burdick and Howson, May 1941 (Robinson, 1941).

The 1941 Landscape Development Plan included designs for most areas with tree and foundation planting suggestions (Figures 24 through 27). Layout plans were prepared for each military unit on the post showing the location of all structures, streets, and parking areas. In addition, the plan gave suggestions for the location of drill and recreation locations, listing possibilities such as firebreaks areas, the parade ground, and west of B and A Avenues. It mentions that the development goal of the post is to preserve the park-like character, situated as it is in a national forest. It goes as far as to mention using signs, guardrails on roads, and parking areas of a design suited to a naturalistic setting, and recommends one check the National Park Service for guidance.<sup>34</sup> The informal character of the natural growth

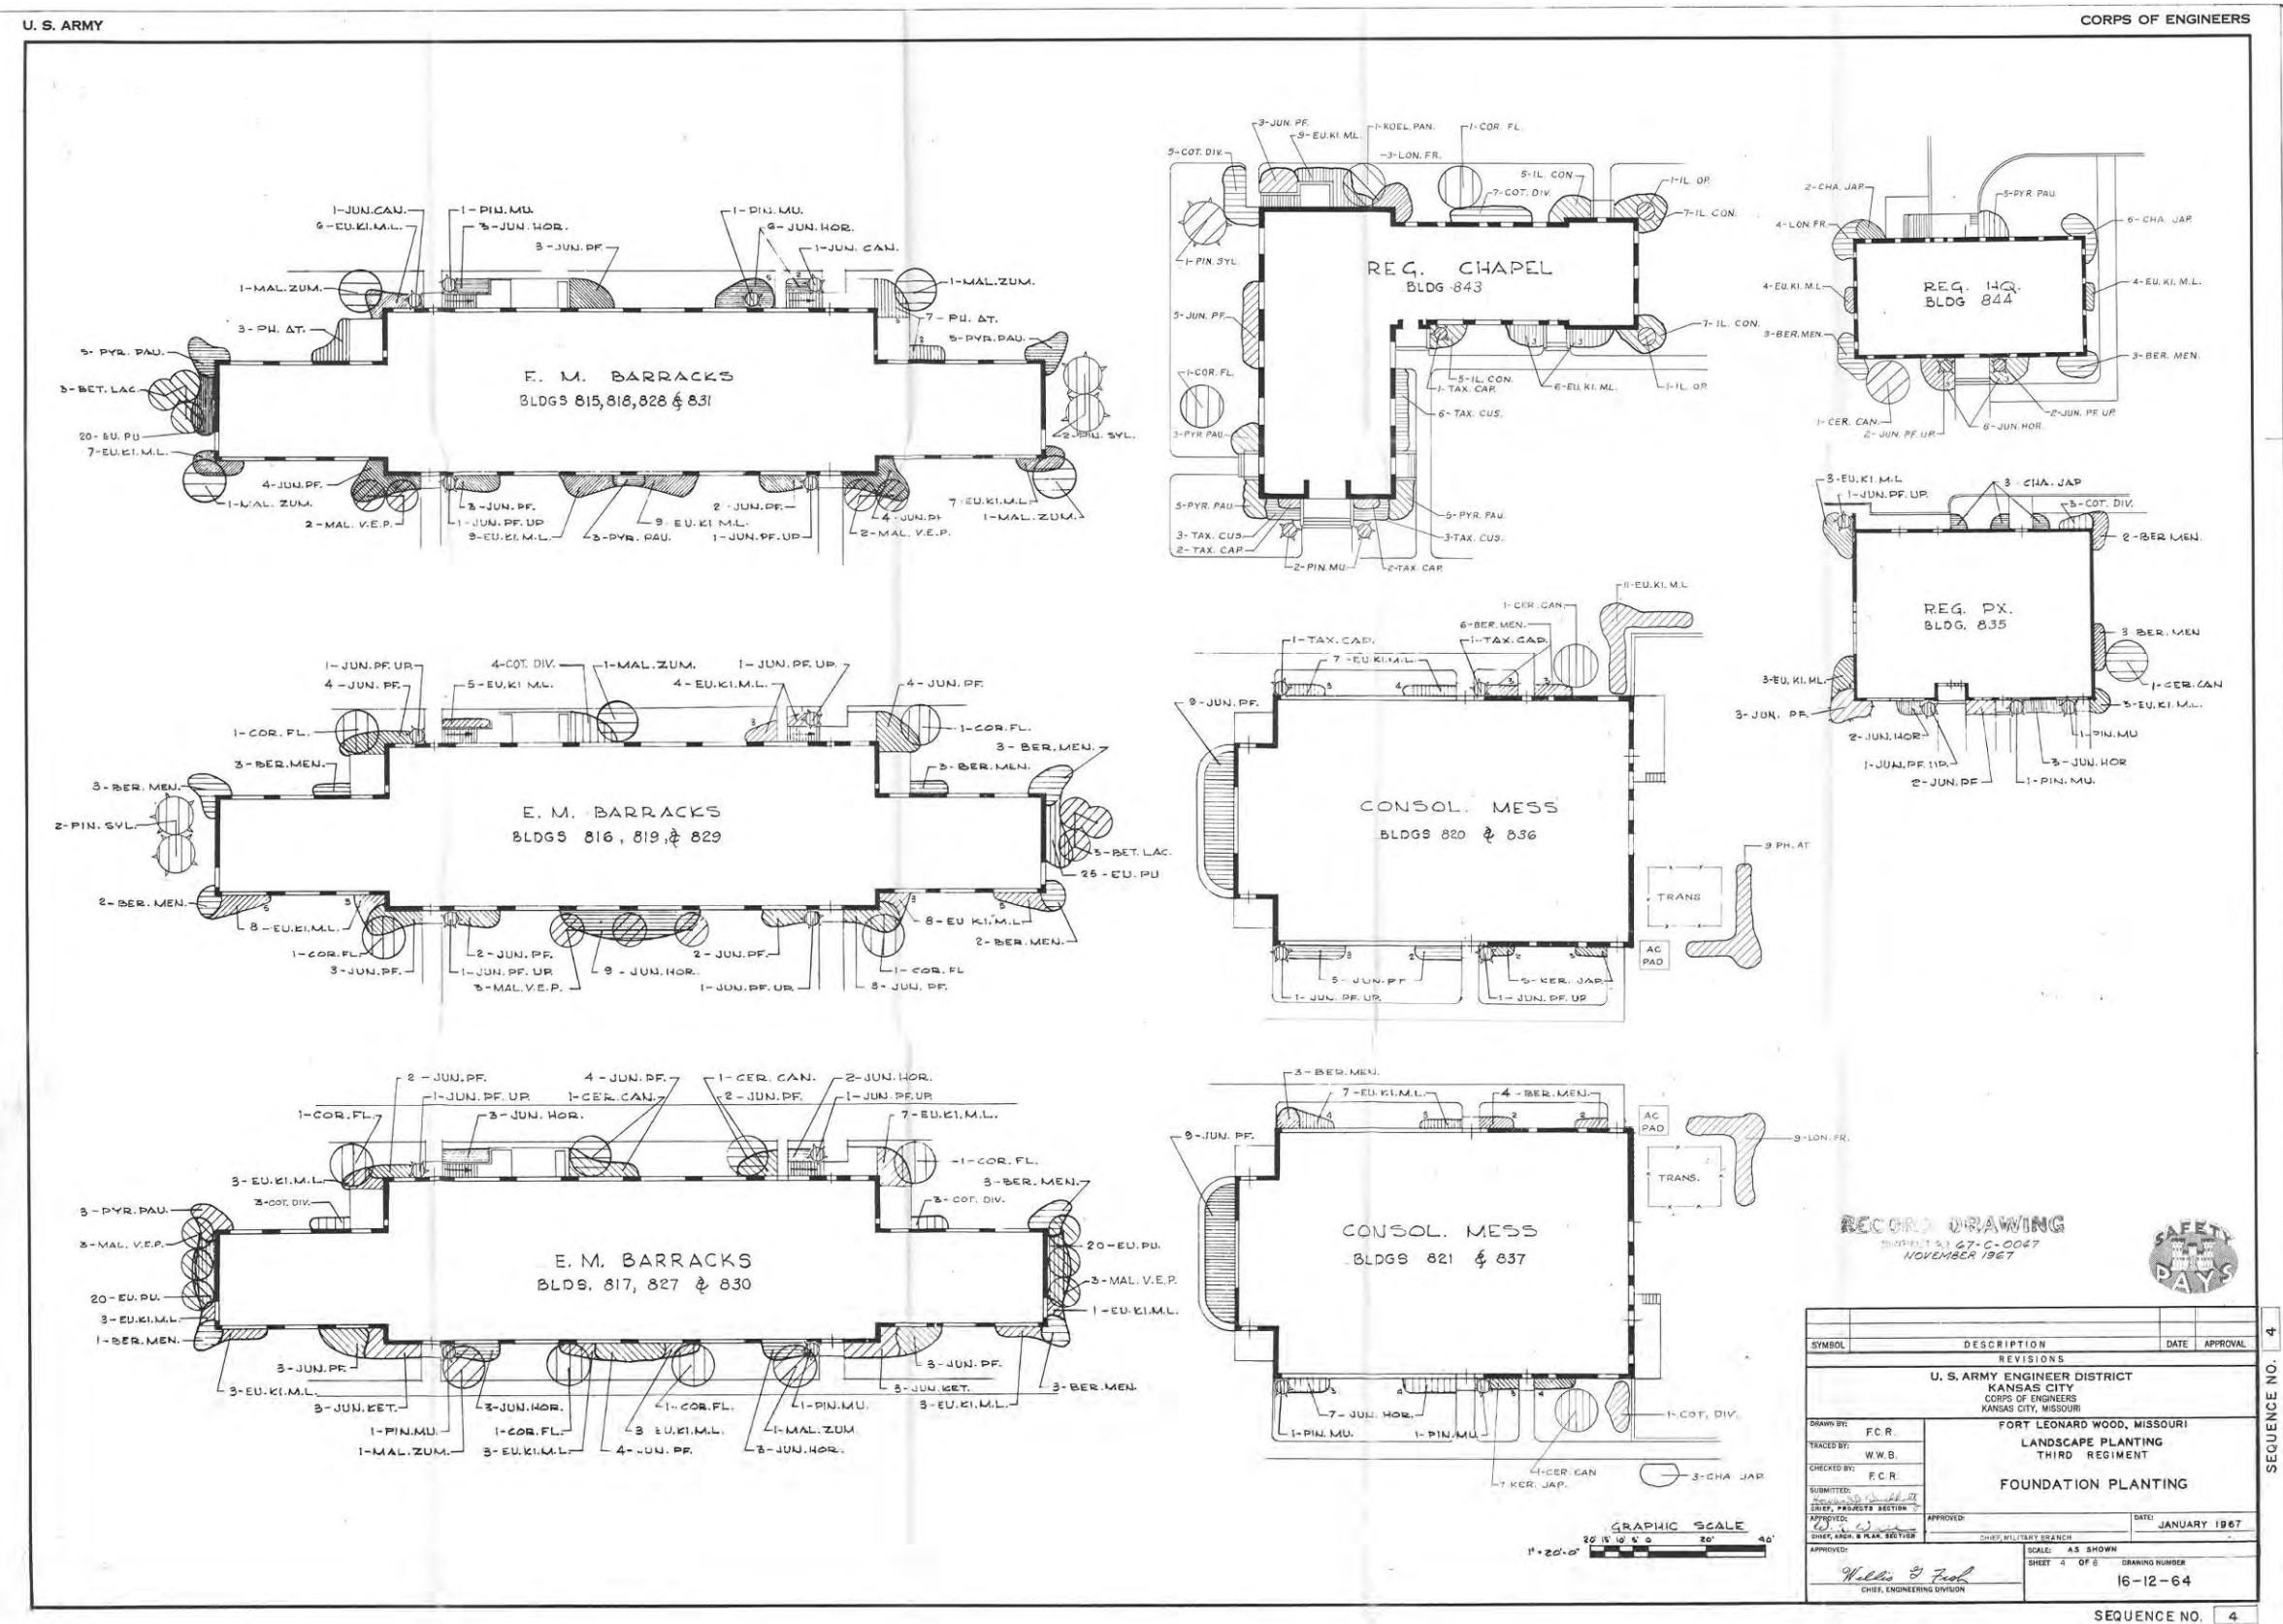
Figure 26. Landscape Planting, Third Regiment, Army Engineer District, Kansas City, January 1967 (courtesy, USAES History Office, FLW).

As FLW became a permanent installation, another report titled *Landscape Planting and Maintenance Plan* was written, although it was revised multiple times with the last revisions in 1968.<sup>36</sup> This report, echoing the 1941 development plan, stresses that any future plantings should be informal in nature. It was noted in the report that formal designs required excessive maintenance and tend to accent the regimental character of a military post.<sup>37</sup> It also noted that landscaping in the cantonment was to be limited to community facilities, the post exchange, theaters, bachelor officers' quarters (BOQ), barracks, hospitals, chapels, family quarters, administrative, school and research buildings, and other areas such as main entrances, and areas adjacent to athletic facilities and parks.<sup>38</sup> Not to receive any attention were the warehouse area, industrial areas, and WWII temporary buildings slated for removal within ten years.

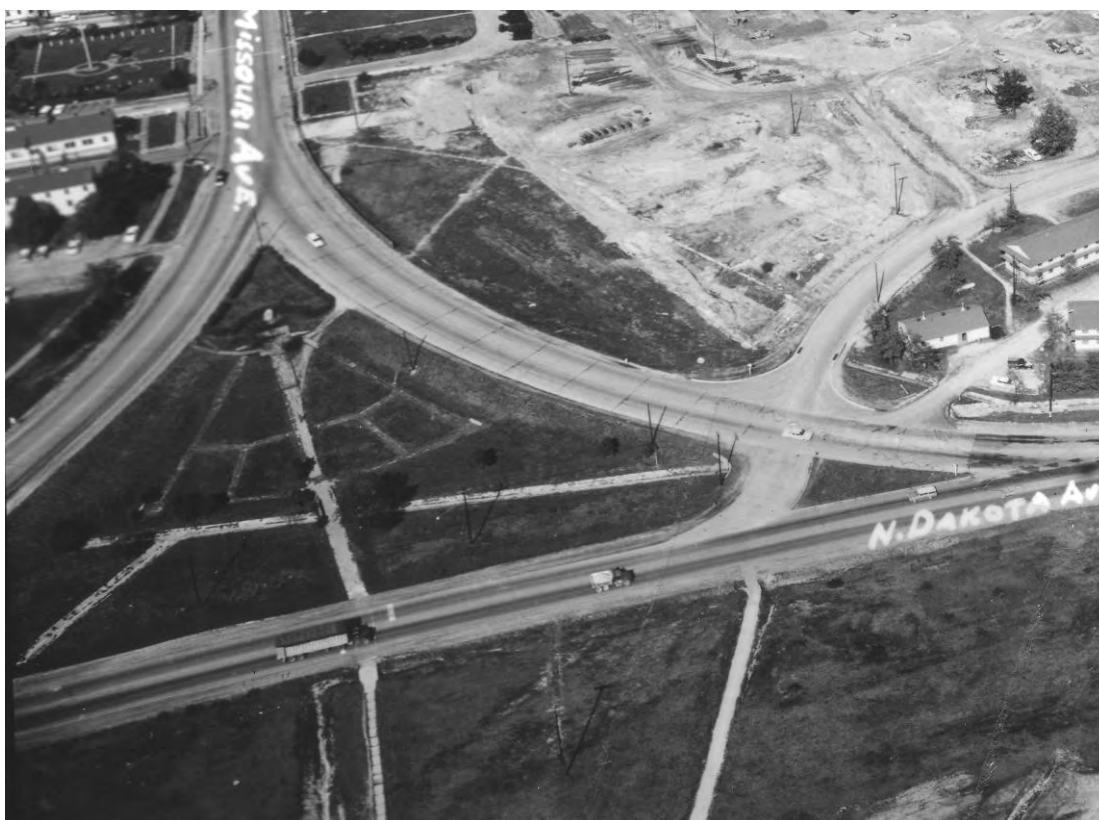
Figure 28. A low oblique photograph showing Veterans Park and construction on the new Health Center, October 1962 (NARA College Park, RG111-SC, photo 602 982).

Veterans Park is located on a triangular piece of land formed by the intersection of North Dakota Avenue and Missouri Avenue. The park, adjacent to the Health Center, is at the entrance to the cantonment and the parade ground (Figure 28). The park contains elaborate POW stonework paths, seating areas, a bridge, and a drainage ditch and is considered to be some of the most significant stonework on the installation.

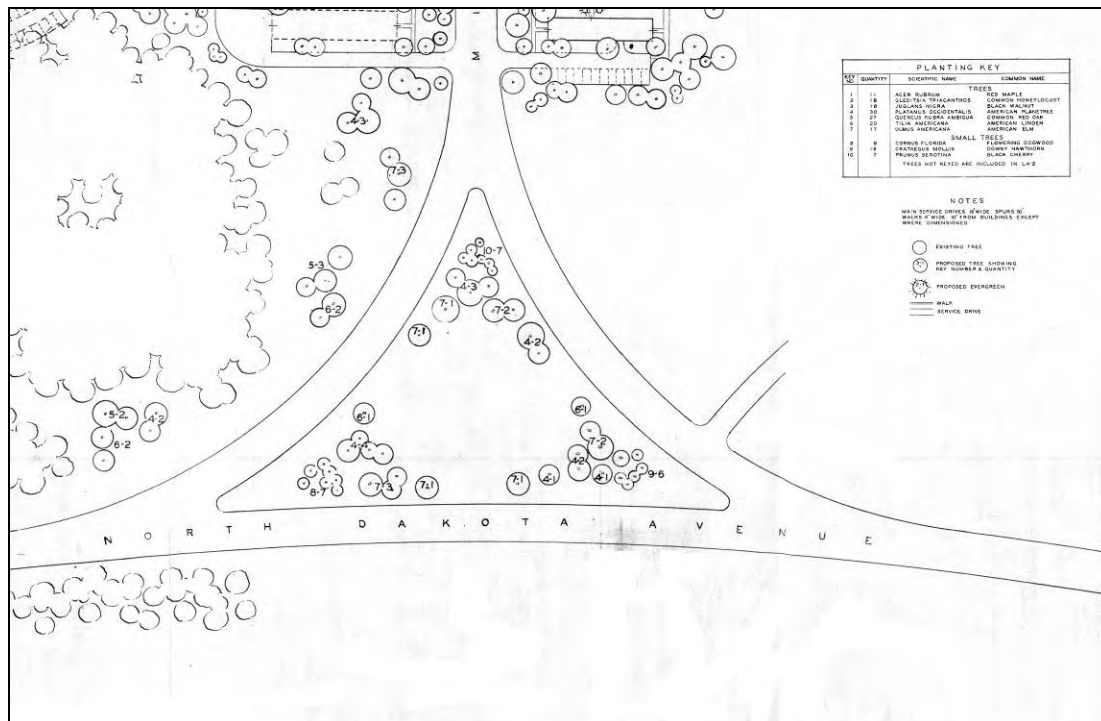
Figure 29. 1941 planting plan for Veterans park which accompanied Alvord, Burdick and Howson plans for Post Headquarters (courtesy, USAES History Office, FLW).

A 1941 plan for the Post Headquarters drawn by Alvord Burdick and Howson, shows a planting plan for Veterans Park (see Figure 29). The site was close in proximity to the headquarters complex and is mostly likely why a planting plan was completed. This planting plan documents existence of the park prior to the POW stonework. In the 1941 design, the small flowering trees are lo-

cated on the three corners, to draw in interest and large shade trees form a backdrop behind them to show off their color. It is assumed this planting plan was never completed since it would have interfered with the stonework completion.

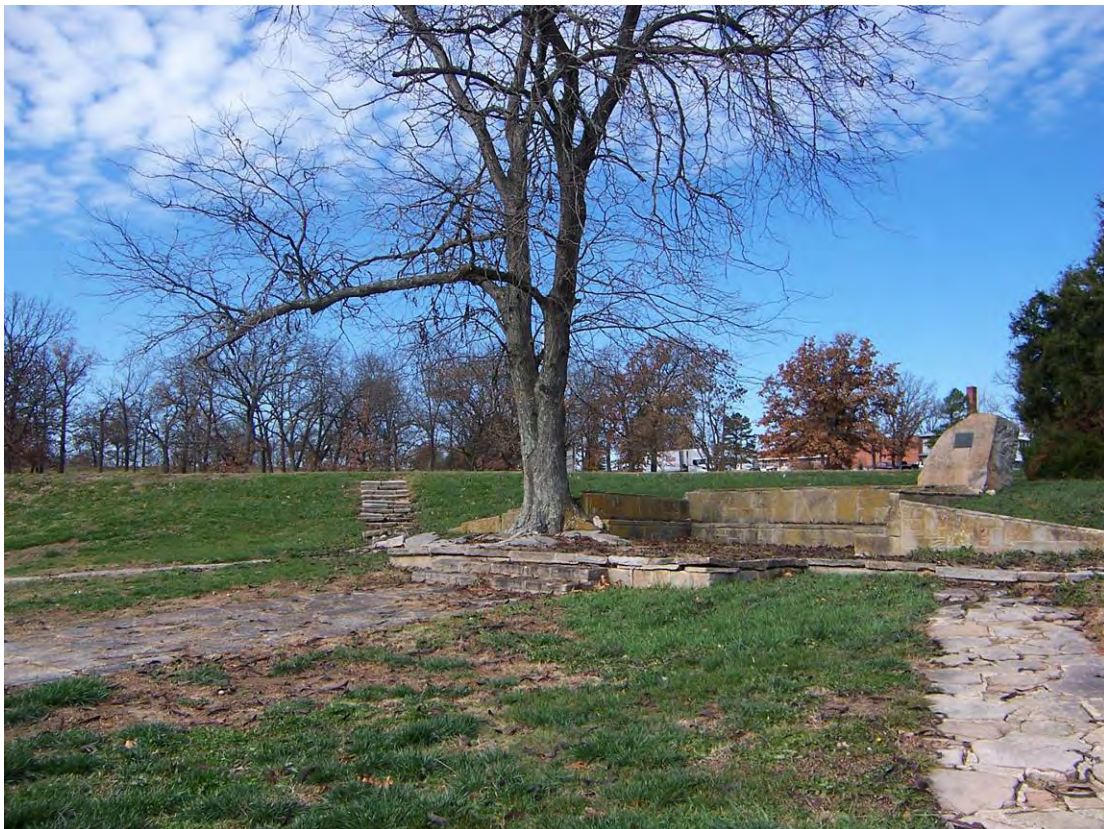
Figure 33. Veterans Park looking northwest at retaining wall, bench, and volunteer tree (ERDC-CERL, 2005).

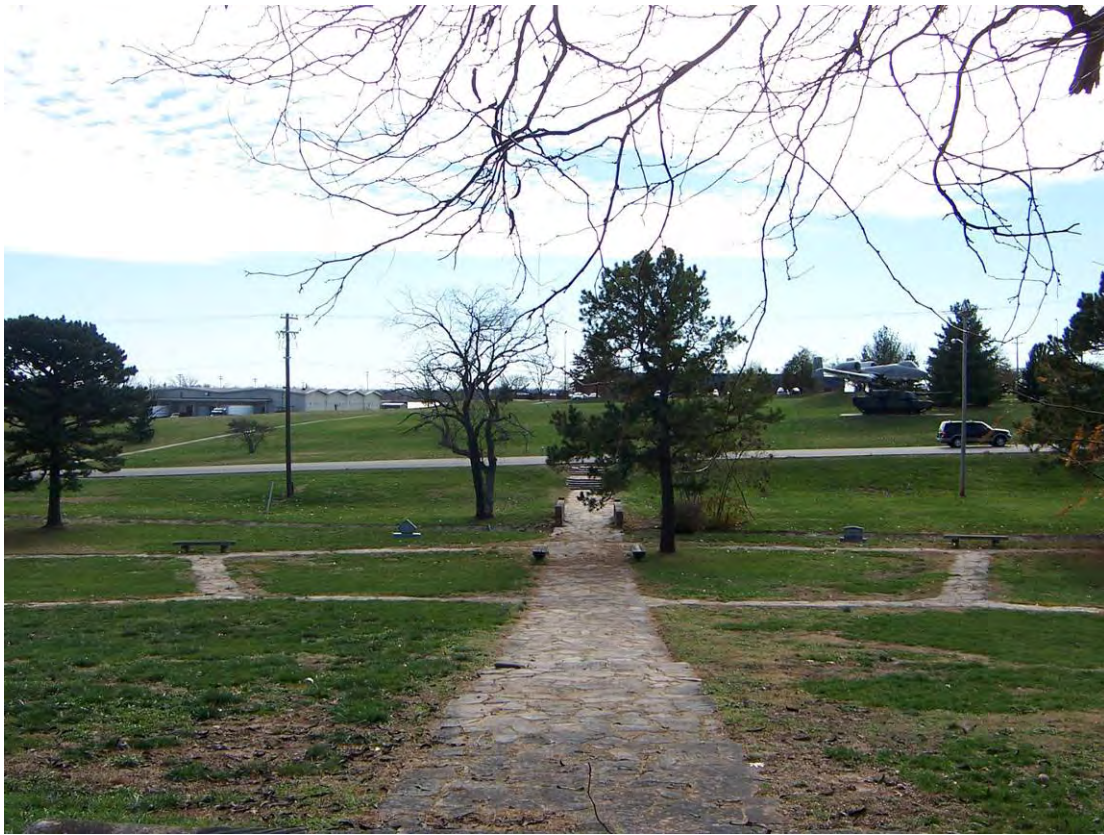
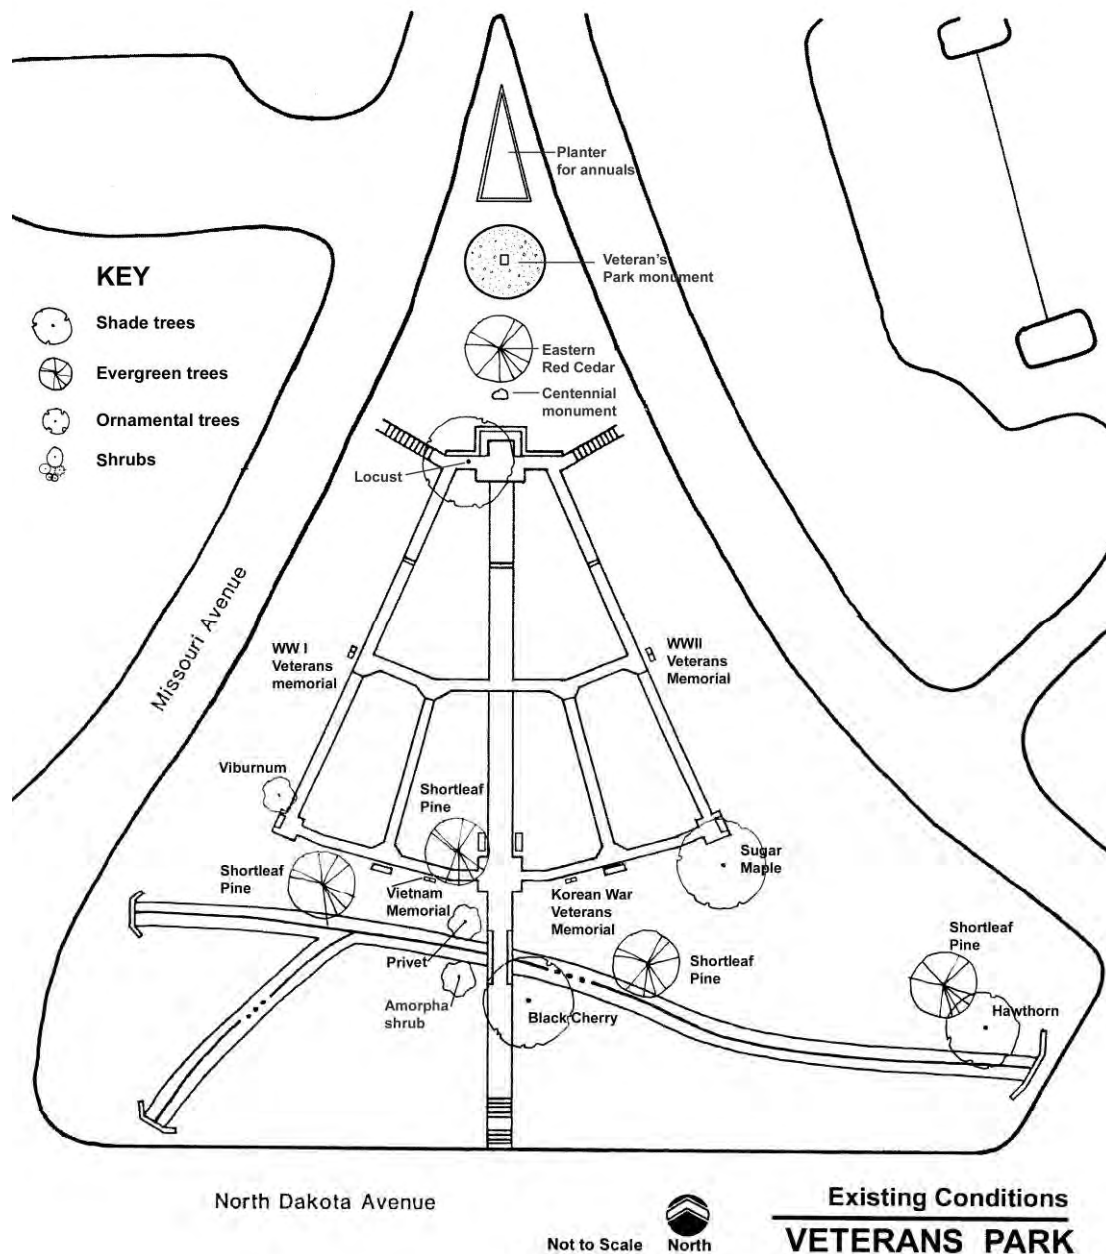
Figure 35. Veterans Park existing conditions (ERDC-CERL, 2005).

The current condition and weedy vegetation affects the integrity of the site (Figures 30-35). The stonework is in need of maintenance. Vegetation within the stonework needs to be removed and some of the stonework needs to be repaired. A large volunteer tree whose roots are destroying the seating area and retaining wall at the north of the park needs to be removed immediately before more damage occurs. Other weedy vegetation throughout the site needs to be removed. The entire site needs landscaping.

The location of the park at the entrance to the cantonment is a focal point of the installation. At this time, the park is underutilized and in need of landscaping and stonework repair. The park needs shade, more visible places to sit, and easy pedestrian access. Future enhancement should consider encouraging hospital patrons to use the site.

- Repair, replace, and restore the POW stonework. All of the steps are in need of repair and are potentially dangerous. In addition, remove vegetation and weeds from the stonework. This stonework serves as the character (backbone) of the park and holds its significance.

- Replace weedy vegetation with a more complex planting plan including evergreens, large shade trees, and small ornamental trees with year-round interest. The following existing trees and shrubs need to be removed because they are damaged, weak, leggy, and not fitting for a formal park setting: the large locust tree causing damage to the stonework, the Black Cherry tree adjacent to the bridge, the hawthorn tree in the southeast corner, and the Amorpha and privet shrubs near the bridge.

- Use shrubs and smaller vegetation to accent the monuments with care not to plant too close to avoid maintenance problems in the future.
- Recommend replacing railroad tie planter at north end of park with something more attractive, possibly a lower stone planting bed. A stone bed should be compatible with, but not replicating, the POW stonework already on the site. Use this bed to draw focus to the park and to highlight the stone monument at the top.

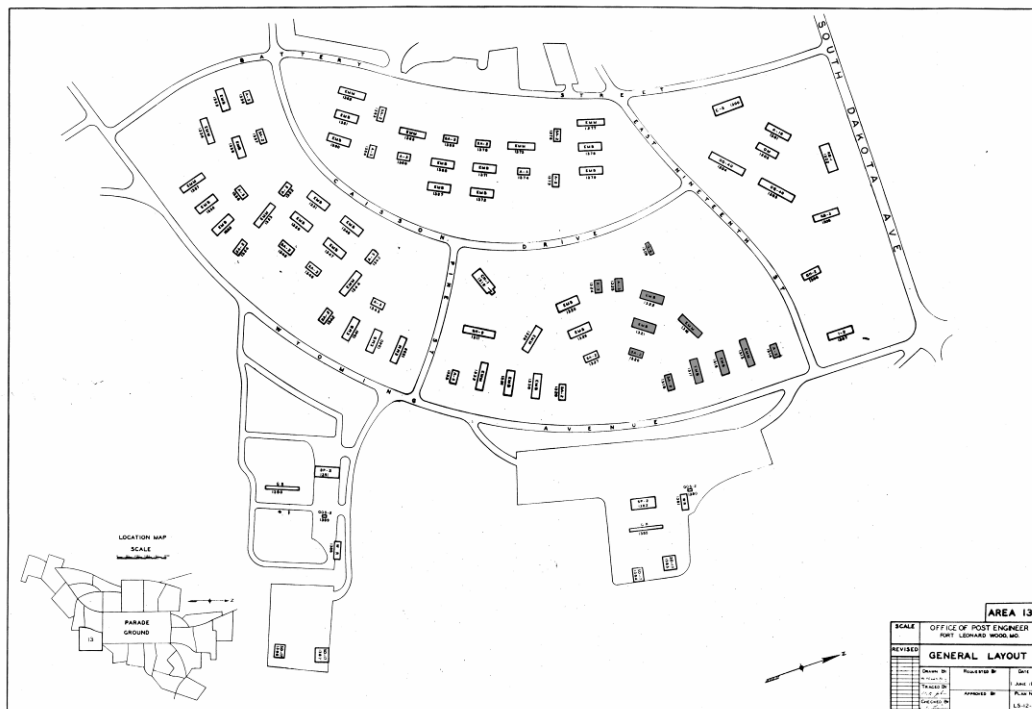
Figure 37. Plan for the “General Layout of Area 13, Office of the Post Engineer, June 1945”. Shaded buildings remain today (FLW, Directorate of Public Works).

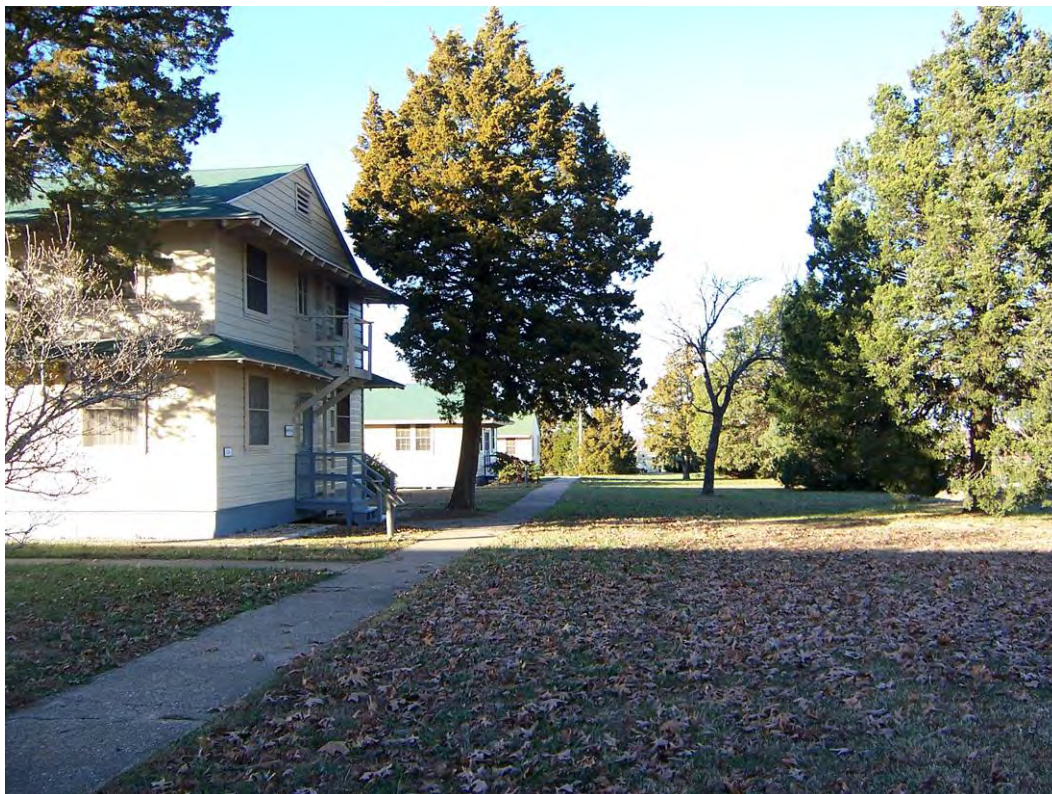
Figure 38. Photograph showing the formal military layout of some of the buildings (ERDC-CERL, 2005).

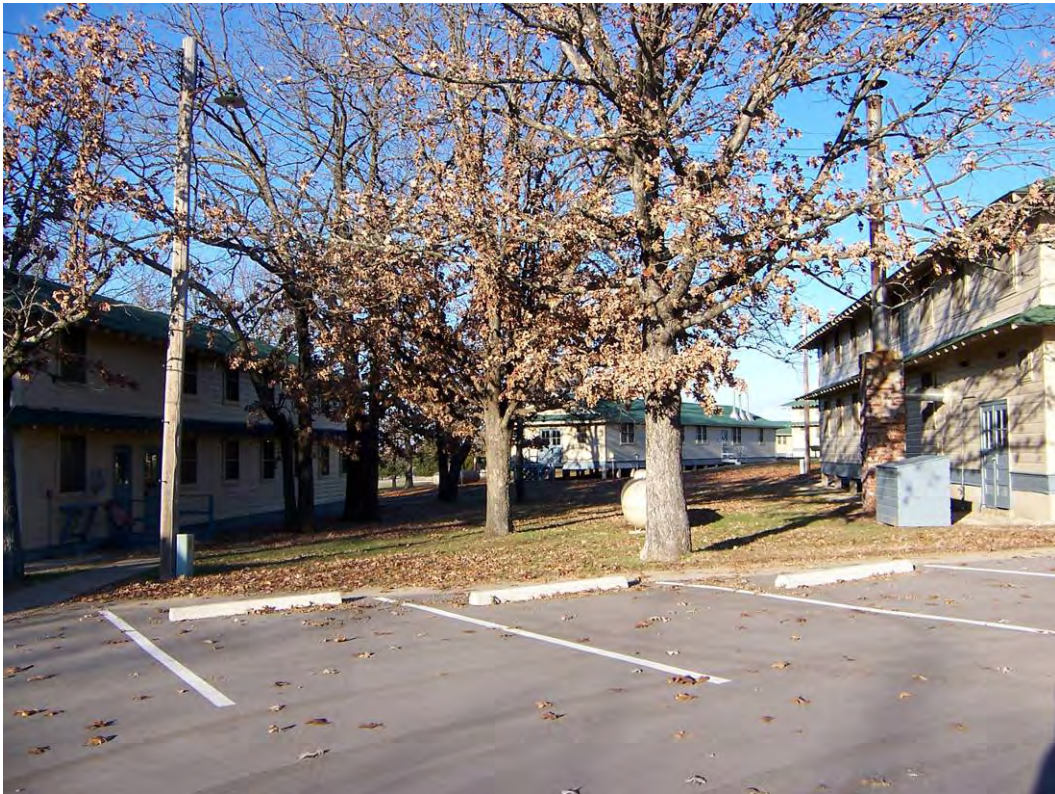
Figure 39. Photograph showing WWII temporary buildings built parallel to the contours (ERDC-CERL, 2005).

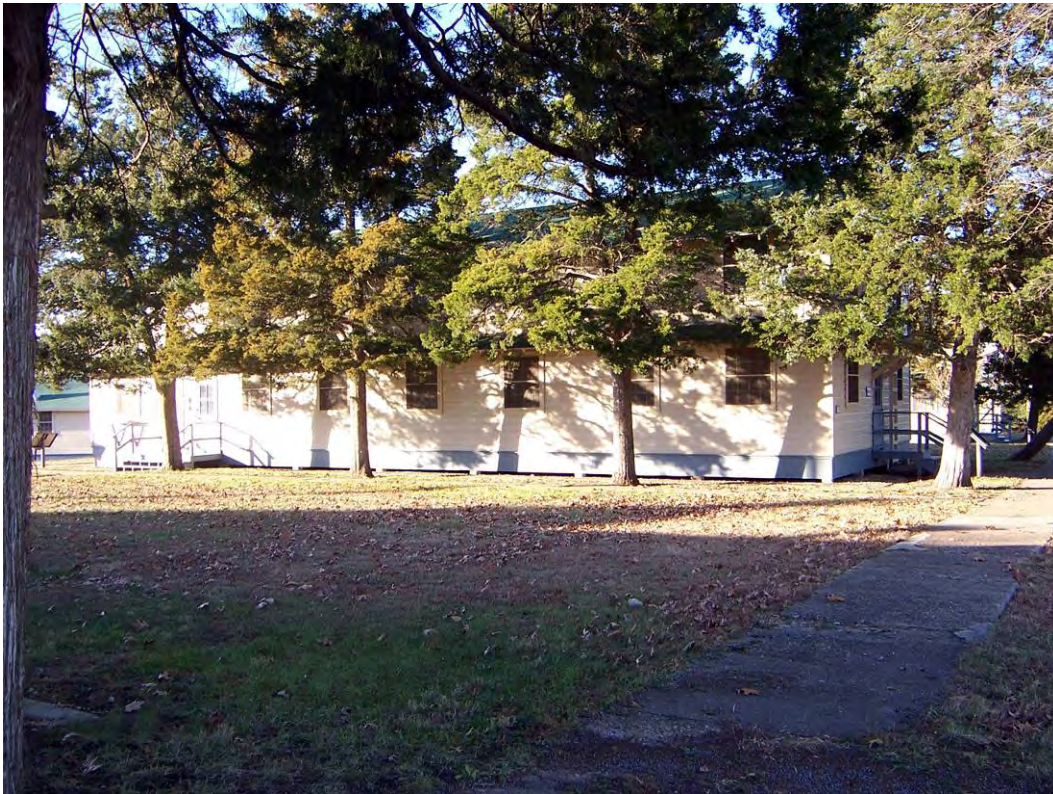
Figure 41. Evergreens planted along the buildings (ERDC-CERL, 2005).

The vegetation on the site is a mix of native oaks along areas of topography and a mix of mostly evergreens planted along the foundations of buildings most likely by Soldiers (Figure 41). The current condition of the historic district is good (Figure 42). The recently constructed memorial parks adjacent to the historic district is a compatible land use, enhances the area, and preserves the open space. The memorial parks, the parking lot, tanks displays and their associated features were concurred with the MSHPO prior to their construction. The chapel, which was moved to the site in 1999, has continued use by the MP brigade. Buildings in the historic district were recently re-roofed and painted in compliance with maintenance manuals.<sup>50</sup>

- It is recommended that, as the cedar trees planted directly adjacent to buildings are lost, that they be replaced with smaller species more in scale with the buildings such as ornamental trees and shrubs of varying size. Care should be taken to not plant these ornamental trees and shrubs too close to buildings so they touch and create moisture problems. Larger shade trees and evergreens should be planted farther from the buildings where they will provide needed shade but be less of a maintenance concern (Figure 45).
